# Existing Structures Engineering, Inc.

**Riverbend Condominium**

**3360 S. Atlantic Ave.**

**December 20, 2022**

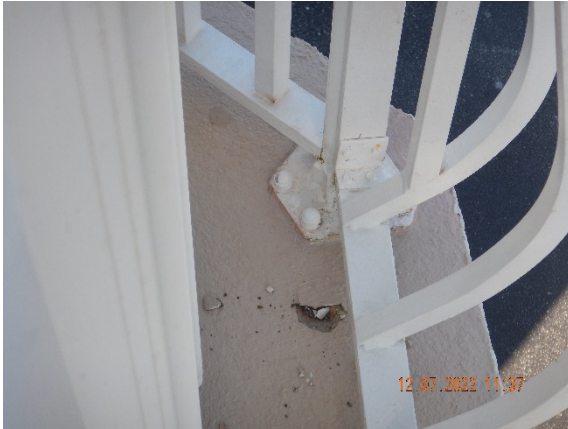
The damage on the reinforced concrete balconies consisted mostly of edge spalls, window sills, and deck spalls which is common to beachside condominiums. There were also some spot corrosions, and some delaminated stucco. These are all asset preservation items and should be repaired. The balconies are constructed of post-tension cable reinforced concrete and CMU walls.

Photograph 1: Deck spall

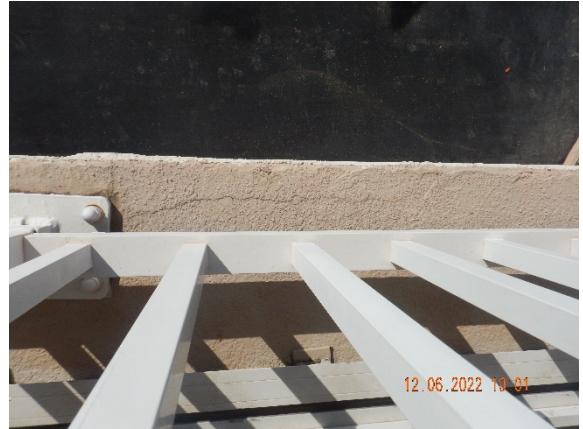
Photograph 2: Edge Crack

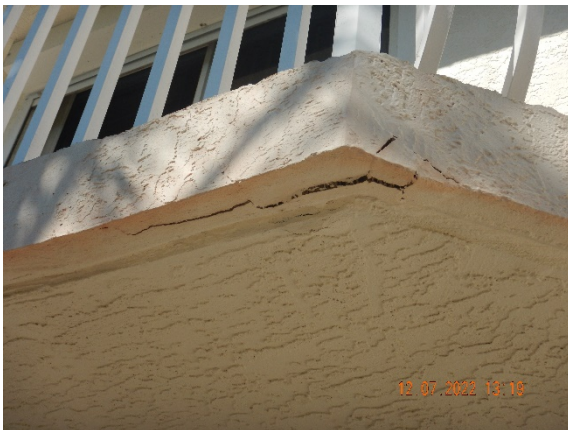
Photograph 3: Edge Spall

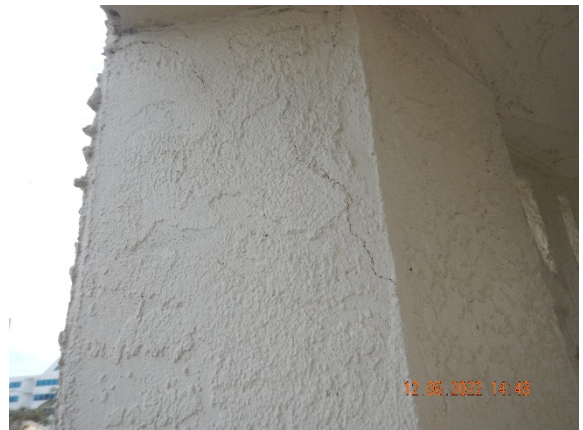
Photograph 4: Column Crack

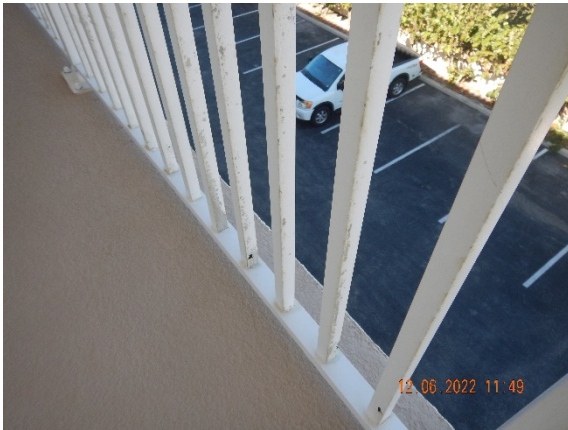
The guardrails on the balconies are of aluminum construction and are up to current building code. The coating is no longer fully adhered to the aluminum in areas and there is significant coating failure and corrosion throughout. It is recommended that the guardrails be replaced at this time. This coating defect has become increasingly common among oceanside communities. After some research regarding coating failure analysis on aluminum guardrails, it has become apparent that this issue stems directly from improper surface preparation. Aluminum railings can last 20 plus years in a highly corrosive environment if properly surface prepped, properly coated and correctly maintained. New aluminum guardrails should also have a 5 (or more) year warranty. Balcony coating and balcony guardrail pricing have been input into the engineering estimate under Alternates. This is an asset preservation item as well as an aesthetic one.

Photograph 7: Typical Railing – Coating Failure

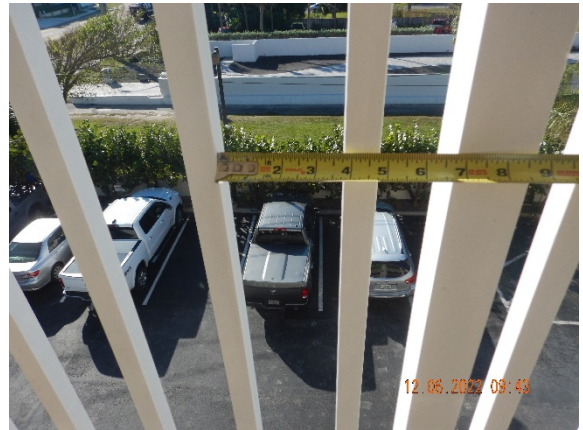
Photograph 8: <4" spacing

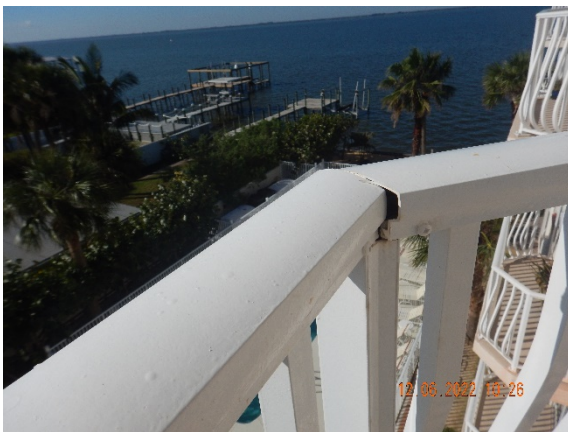
Photograph 9: Railing Alignment Issues

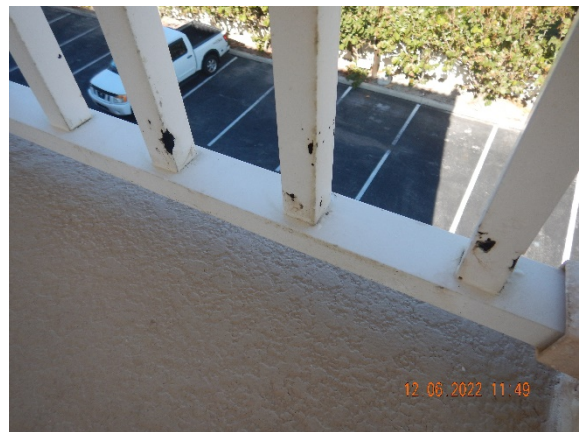
Photograph 10: Coating Failure/Picket Corrosion

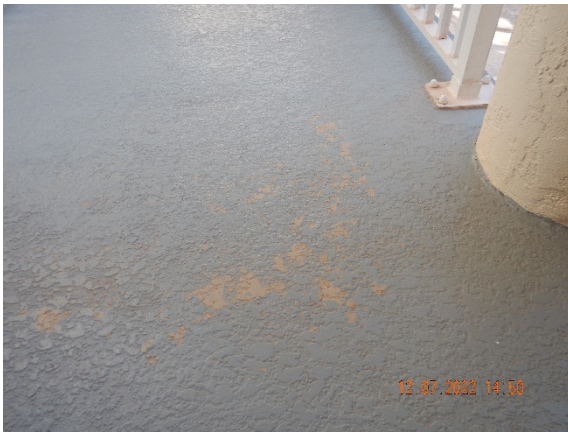
The walkways currently have a knock down textured acrylic coating system installed. On most floors, the coating appears to be at the end of its protective life cycle. Since it is recommended that new rails be installed, it would be a good opportunity to install a new acrylic coating system. A new acrylic coating system will extend the service life of the walkways as it will delay corrosion of the reinforcing bars. Coatings are your first line of defense against the harsh coastal environment. This is an asset preservation item as well as an aesthetic one.

Photograph 11: Walkway Coating Failure

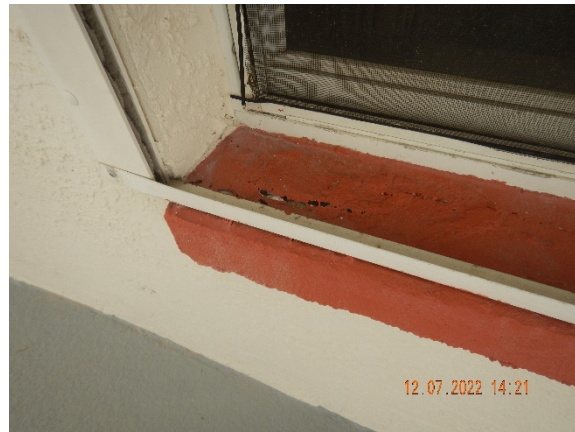
Photograph 12: Walkway Sill Spall

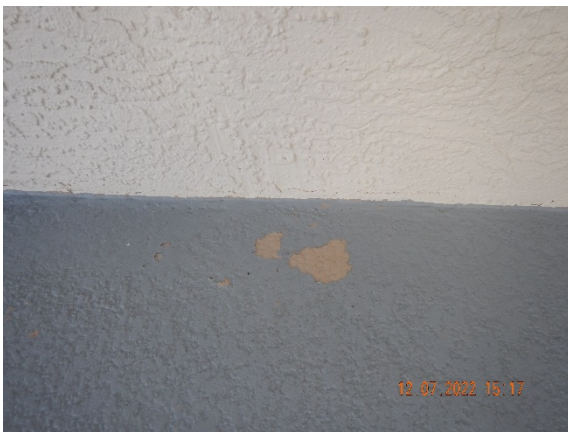
Photograph 13: Walkway Coating Failure

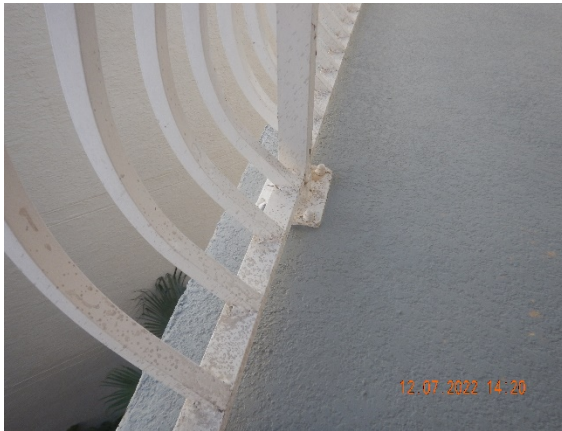
The guardrails on the balconies are of aluminum construction and are up to current building code. The coating is no longer fully adhered to the aluminum in areas and there is significant coating failure and corrosion throughout. It is recommended that the guardrails be replaced at this time. This is an asset preservation item as well as an aesthetic one.

Photograph 15: Railing Coating Failure

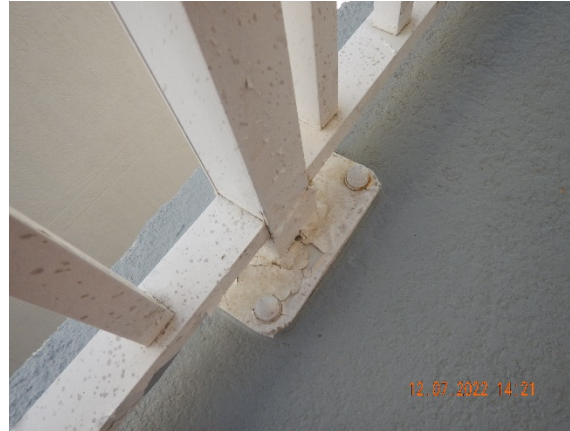
Photograph 16: Railing Coating Failure
